3.13 Groundwater and Hydrology

3.13.1 Groundwater Availability

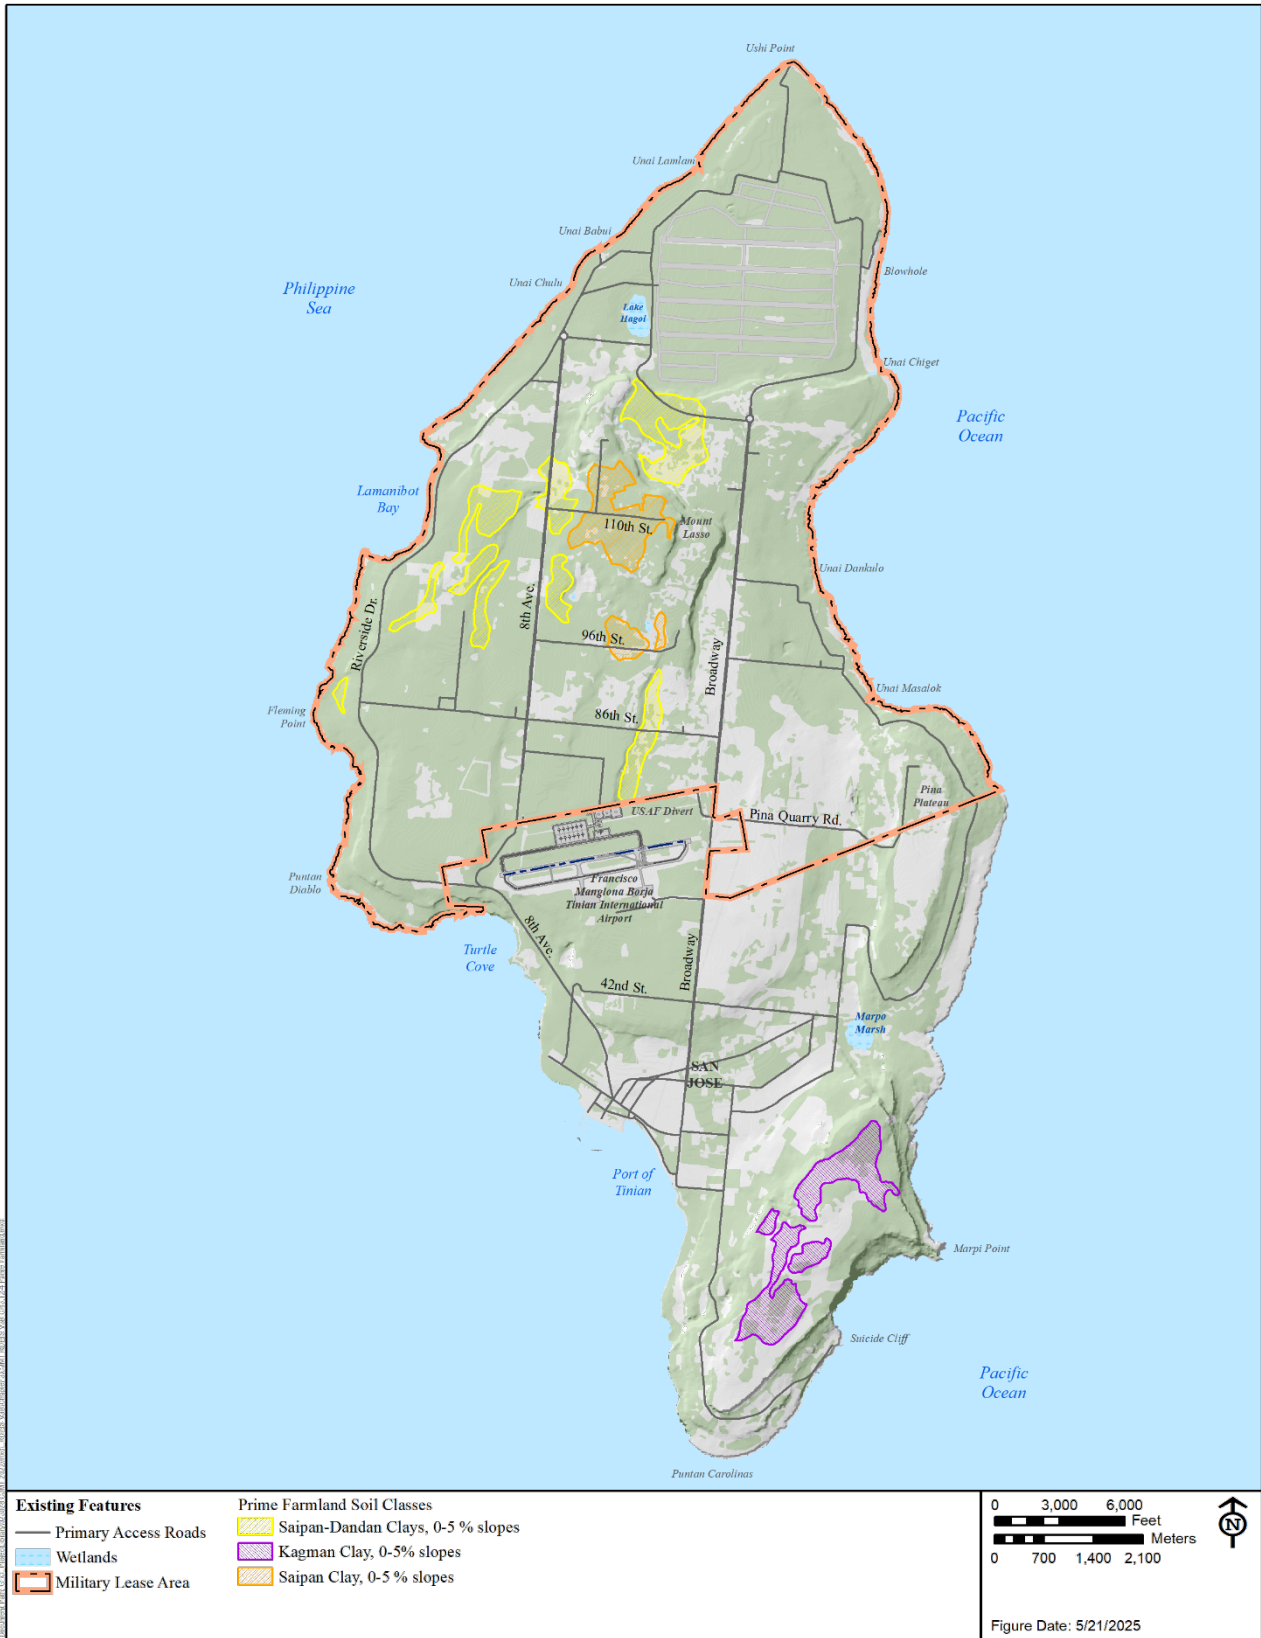
Figure 3.12-4 Tinian Prime Farmland Soils

Soils that are best suited to producing sustained high yields of crops are identified as prime farmland (U.S. Department of Agriculture 1989). Prime farmland soils do not have to currently be used for cropland. Areas with these soils can be forest land, pastureland, cropland, or other land (Natural Resources Conservation Service 2012). Prime farmland soils on Tinian are shown in Figure 3.12-4. Within the Military Lease Area, prime farmland soils include Saipan-Dandan clays (0 to 5 percent slope) and Saipan clays (0 to 5 percent slope) and comprise approximately 71 percent (1,054 acres) of prime farmland soils on Tinian.

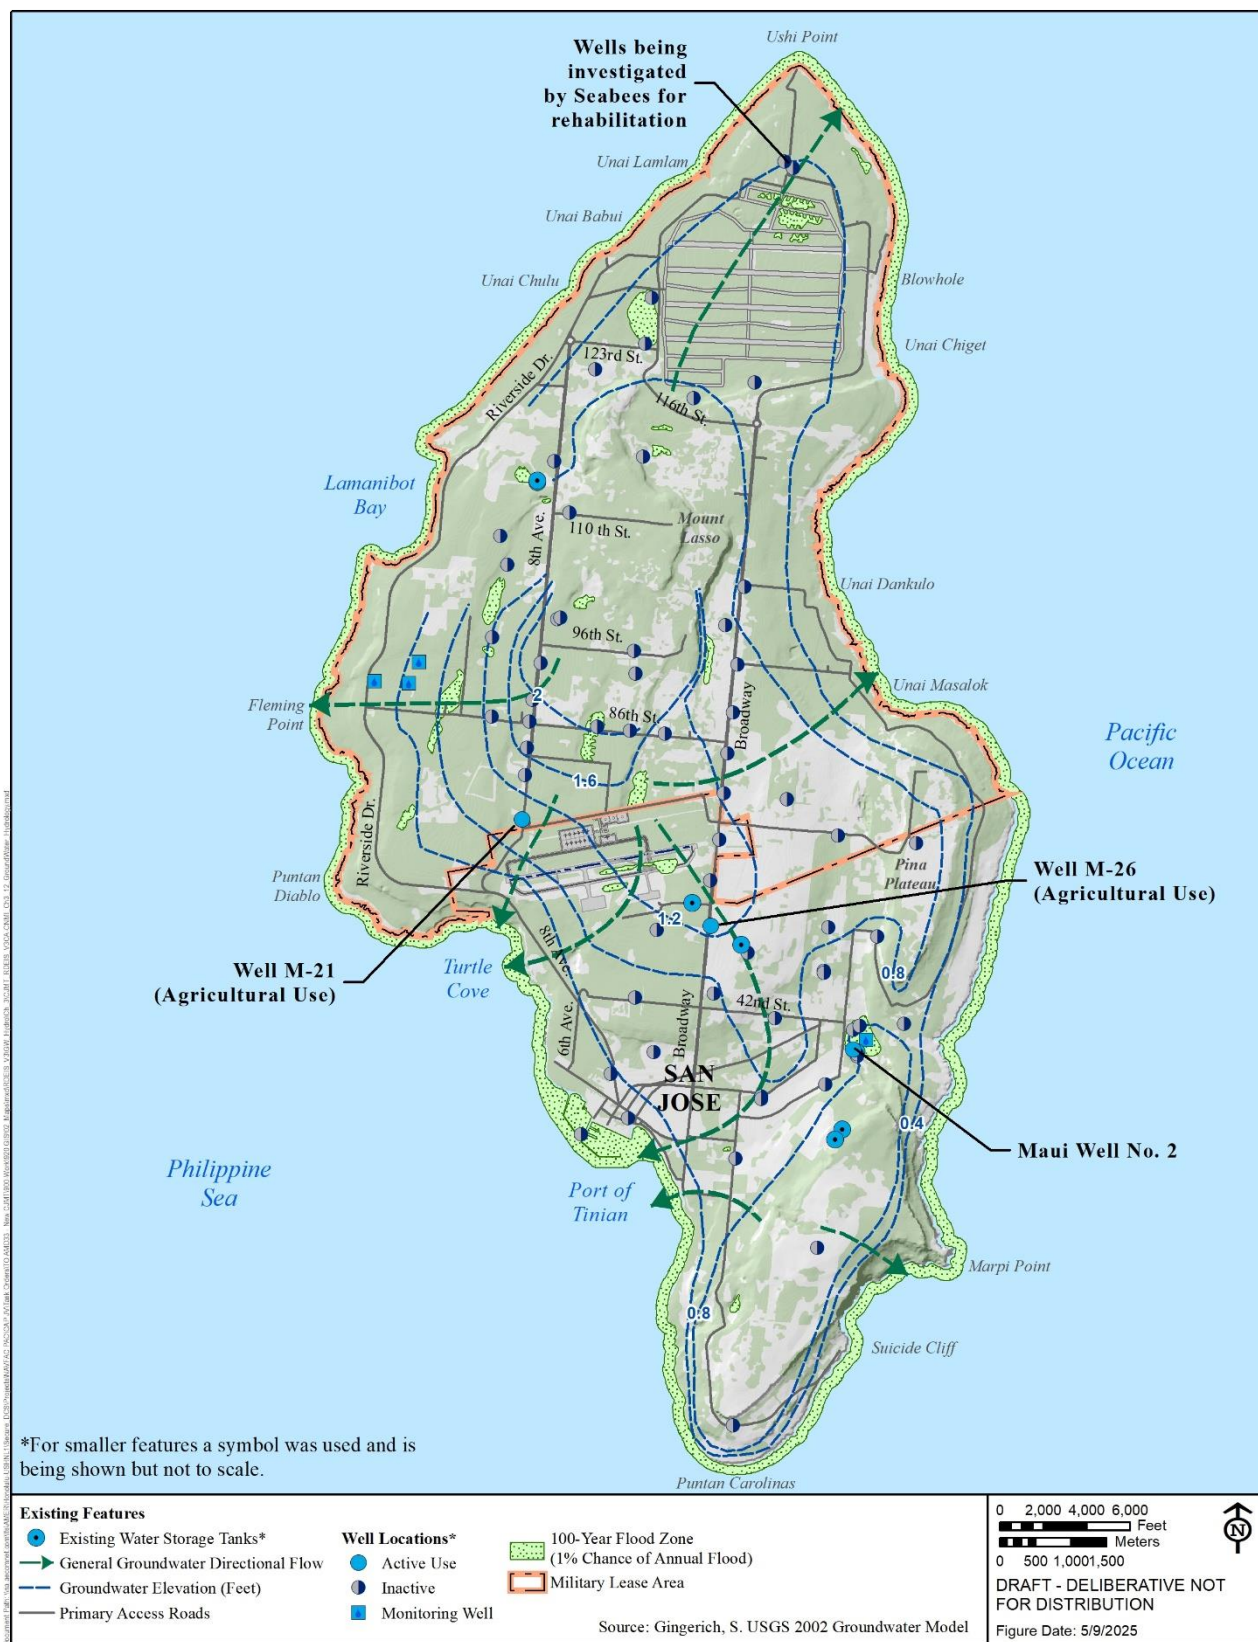
Figure 3.13-1 Tinian Groundwater Wells, Elevation, and Flow Direction

The groundwater table on Tinian (the underground area where water fills the spaces between sediment layers), ranges from sea level around the perimeter of the island to over 3 feet above mean sea level in the central portions of the island. The U.S. Geological Survey estimates the average annual groundwater recharge for Tinian to be approximately 30 inches per year (Gingerich 2002). This translates into approximately 20 billion gallons per year of recharge. Groundwater flows outward from the North Central Highland and the Southeastern Ridge and generally seaward around the island (Appendix M). Figure 3.13-1 depicts groundwater table elevation contours and the general direction of groundwater flow. Most of the fresh groundwater slowly discharges naturally from springs around the perimeter of the island and submarine coastal springs.

Numerous wells have been installed on Tinian, beginning with potentially more than 100 wells installed by the Japanese from 1914 to 1944. Most of these wells were reportedly filled. Between 1944 and 1945, the U.S. installed approximately 40 wells, including Maui Well Number 1. The majority of these wells have been inactive since shortly after World War II, except Maui Well Number 1. Between 1993 and 1997, the U.S. Geological Survey installed 17 wells and rehabilitated 16 World War II-era wells for groundwater monitoring; all of which remain open.

The Commonwealth Utilities Corporation operates the Tinian public potable water system. Until it was disconnected and abandoned, Maui Well Number 1 supplied potable water to Tinian. This Maui-style well, featuring a horizontal infiltration system, was constructed at Makpo Marsh by the U.S. military during World War II. It served as Tinian's primary potable water source until it was replaced by Maui Well Number 2 (Commonwealth Utilities Corporation 2022). Maui Well Number 2 is also located in the Makpo Marsh within the Makpo sub-watershed. Ranchers and farmers pump fresh water from agricultural wells M-21 and M-26 (Figure 3.13-1), which are not regulated for potable water use. Currently, the U.S. Air Force Divert Activities project is using well M-21 to supply construction water (DON 2023).
